TRIPS AND SLIPS CAN CAUSE FALLS FROM HEIGHT

CASE STUDY

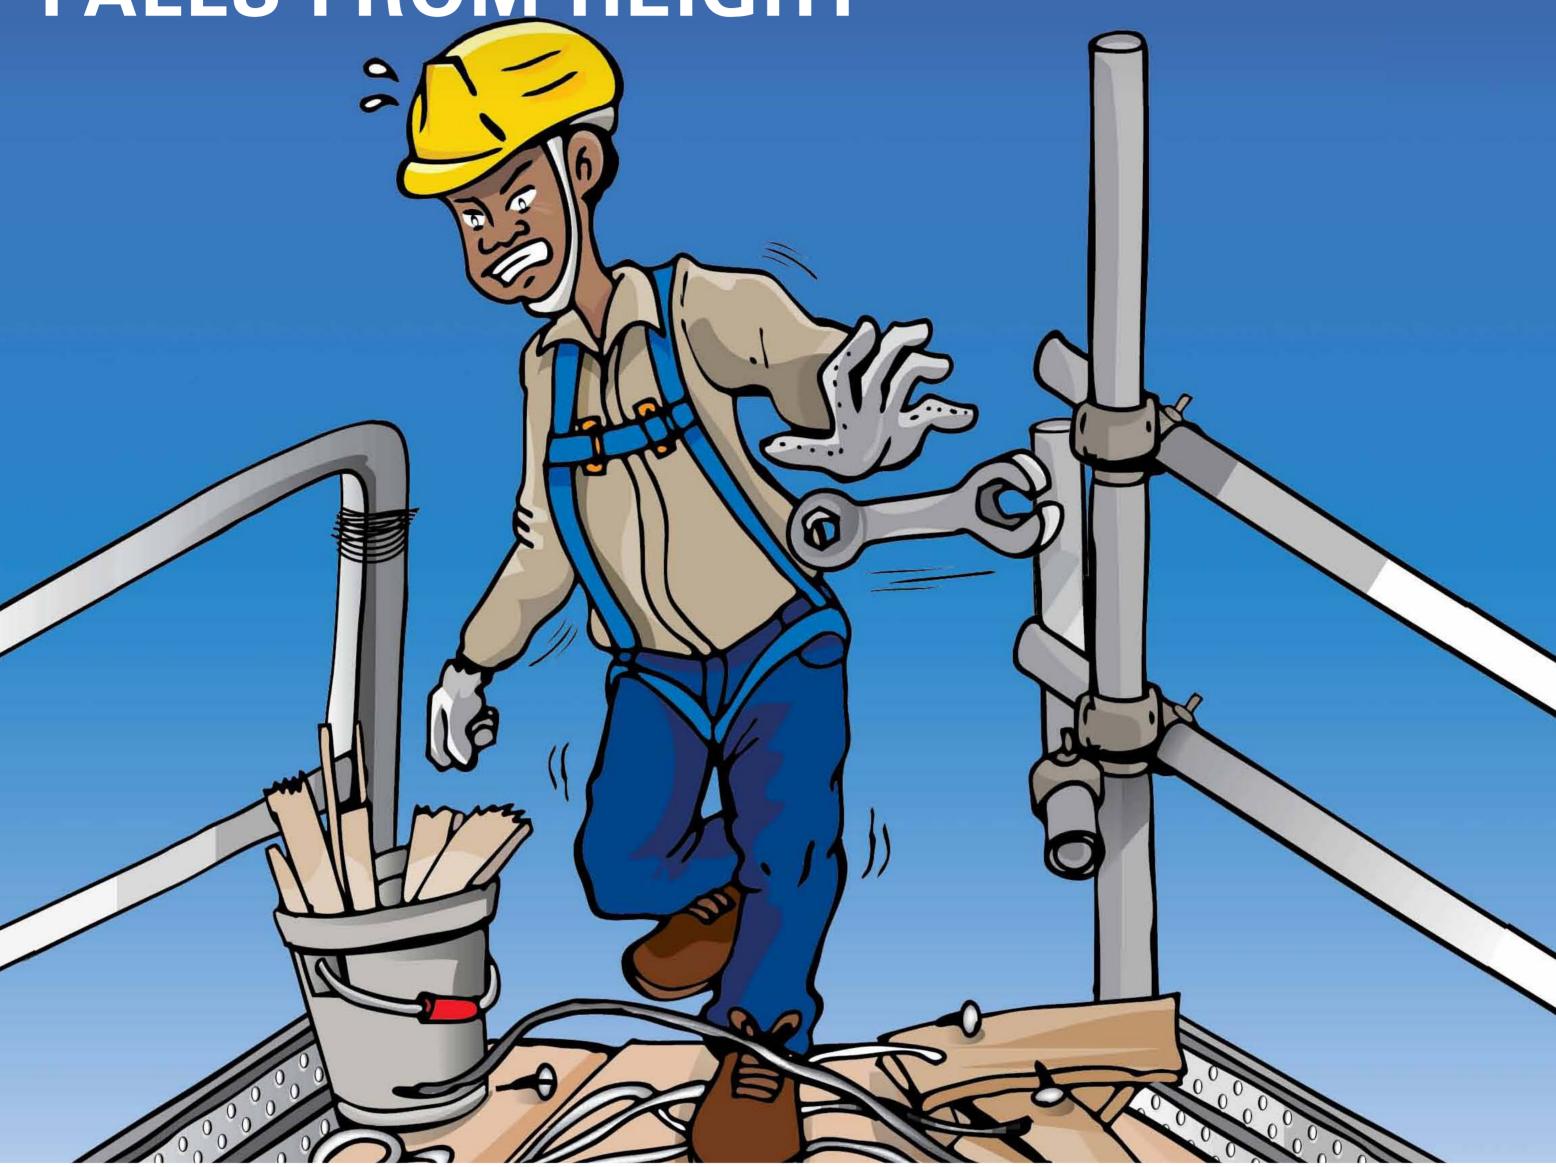
A worker was carrying out drilling operations at the 33rd level of a building. The worker tripped on an electrical extension wire and fell through a floor slab opening within a wooden barricade. He landed on the 32nd level.

The opening through which the worker fell was meant for the staircases (before dismantling). It was unguarded by any effective barrier to prevent falls.

- 1 The electrical distribution box at the corner of the floor slab opening
- 2 The floor slab opening was meant for a staircase before it was dismantled

- 1 The red-white tape and nylon rope used to barricade the two sides of the floor slab opening
- 2 The wooden barricade (guarding only one side of the opening and not the remaining three)

- Practice good housekeeping.
- Provide barriers at floor openings to prevent falls or to cover the openings.
- Provide appropriate lighting and display suitable warning signs to warn workers of potential dangers at work areas.
